Heber Public Utility District

Subject: Water Distribution Report October 2018

Subject: October 2018 Monthly Report

SUBJECT: Heber W.W.T.P. Operation from September 22, 2018 to October 22, 2018

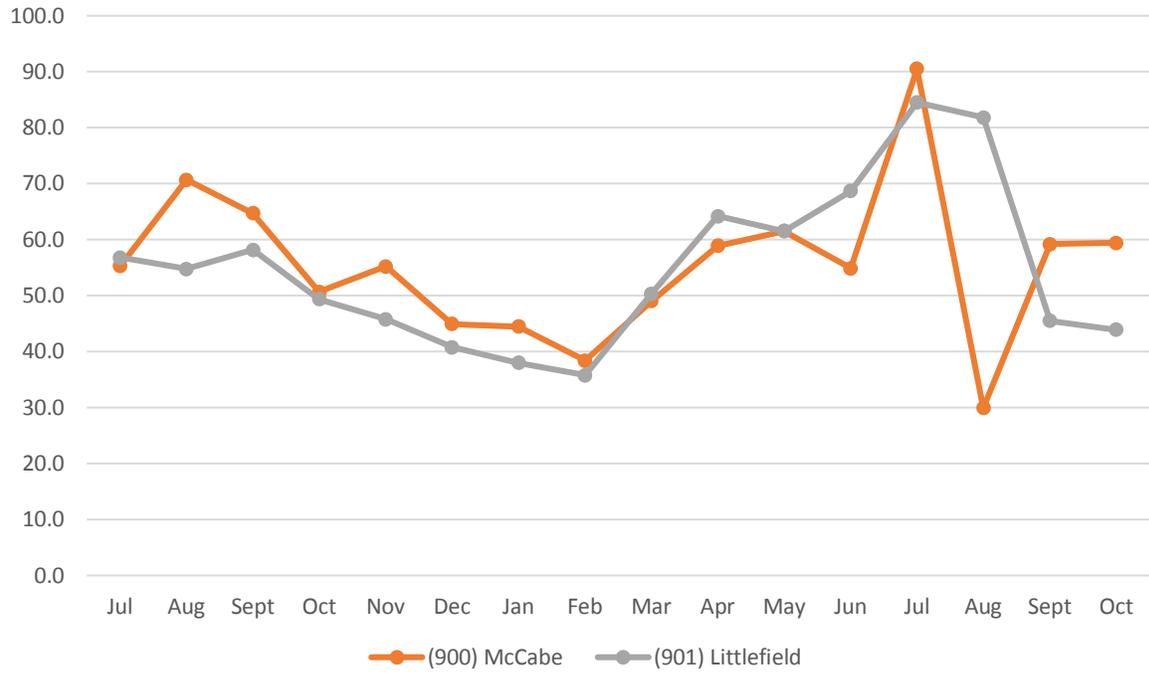
TTHM Data Chart July 2017 to Oct. 2018

On October 09, 2018 collected fourth quarter TTHM's samples and were sent to Clinical Lab of San Bernardino for analysis. The results came in on October 19, 2018 and were below the maximum contaminant level (MCL) for the both sites. The running annual average (RAA) MCL for TTHM's is 80 parts per billion (ppb) and for the 3rd quarter of 2018 we attained a RAA of 59.4 ppb for the Mc Cabe Cove site and 43.9 ppb for the Little Field site. Heber Public Utility District is in compliance with State and Federal water regulations.
