Heber Public Utility District

Report to the Board of Directors

INSPECTION REPORT

Heber Public Utilities District WWTP
1184 Rockwood Avenue
Heber, CA 92249
Imperial County

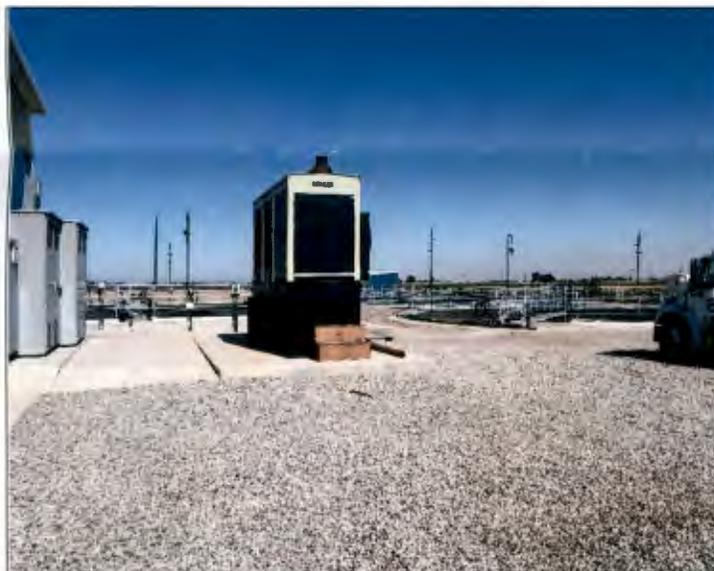
Photo 1.- Emergency power plant

Temporary power and storage capacity is provided to maintain the plant in operation in the event of commercial power failure, also a fence about 6 ft. high was observed around the periphery of the facility to minimize the probability of contact of unauthorized persons and domestic animals with the wastewater disposal facilities. The Permittee retains records of all monitoring information, including all calibration and maintenance records and all original strip chart recordings for continuous monitoring instrumentation, copies of all reports required by the permit, for a period of at least five (5) years from the date of the sample, measurement, report or application.

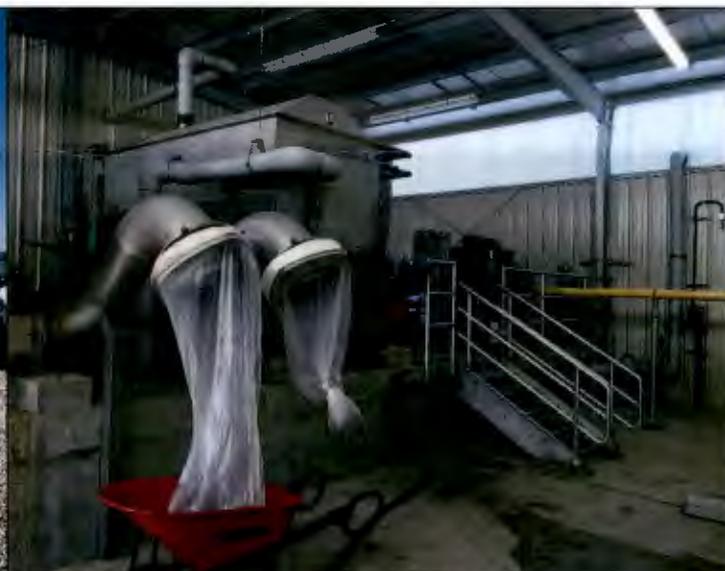
power generators, a small office/laboratory and most of the old appurtenances which remain idle and a new retaining lagoon located in the north of the Facility. The sludge generated from the clarifiers is pumped to a sludge holding tank or the sludge dewatering unit. Once the sludge is thickened it is discharged into a sludge holding container and then transferred to the drying beds for further drying. Sludge is dried on-site for no more than two years and the dried solids are tested as required by the permit. Bio solids collected by the screening mechanisms are disposed at the local landfill in the City of Imperial. All the facilities appurtenances and the mechanical treatment units appeared clean and working adequately throughout the treatment train (Photos No. 1-6).

Photo 2.- Trash removal system

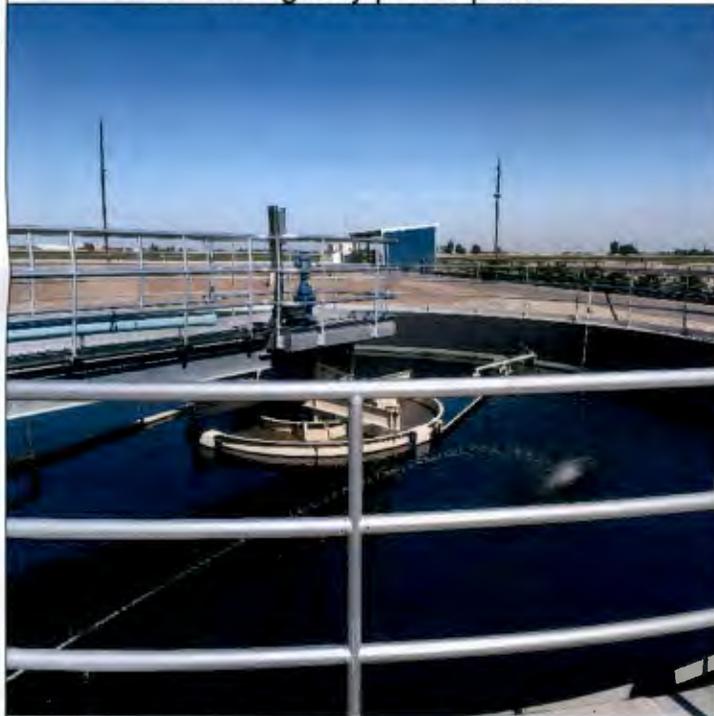
Photo 3.- Secondary clarifier

The old oxidation ditch was not in use during the time of the inspection, a clarifier and the dewatering units were also idle during the time of the inspection, the dewatering unit is normally used during the cold weather station or as required, the clarifier can also be used if required. The wastewater treatment plant is supervised and operated by persons possessing certification of appropriate grade pursuant to Section 3680, Chapter 26, Division 3, Title 23 of the California Code of Regulations and the operating personnel are familiar with the contents of the operating permit.

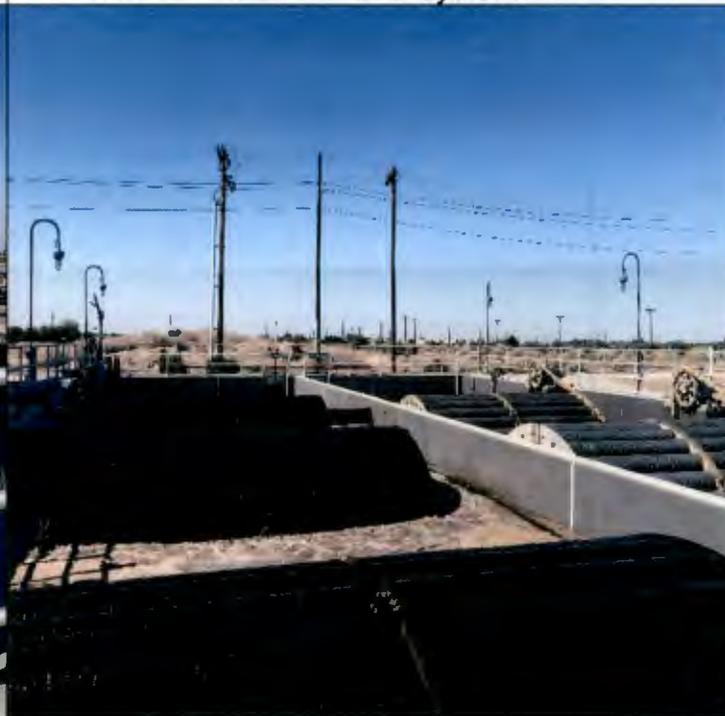
Photo 4.- Oxidation ditch

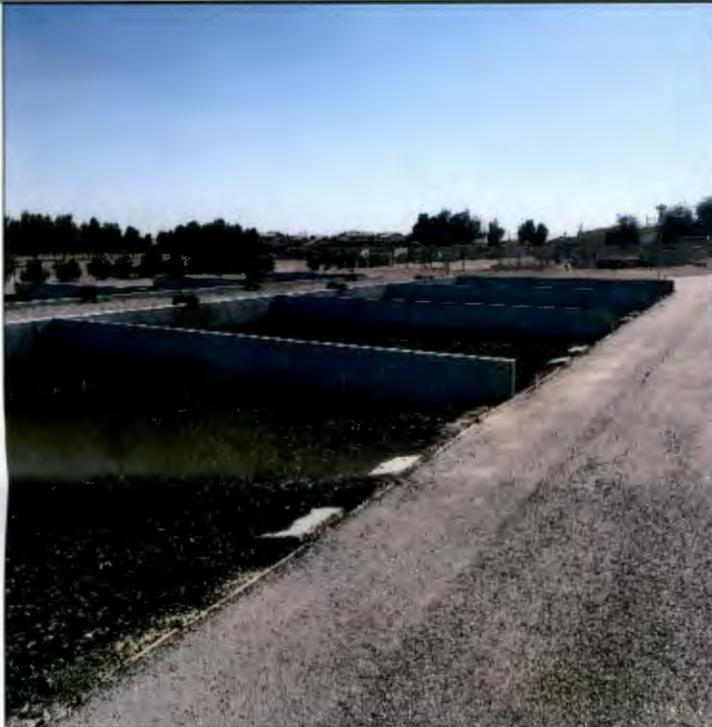
Photo 5.- Drying Beds

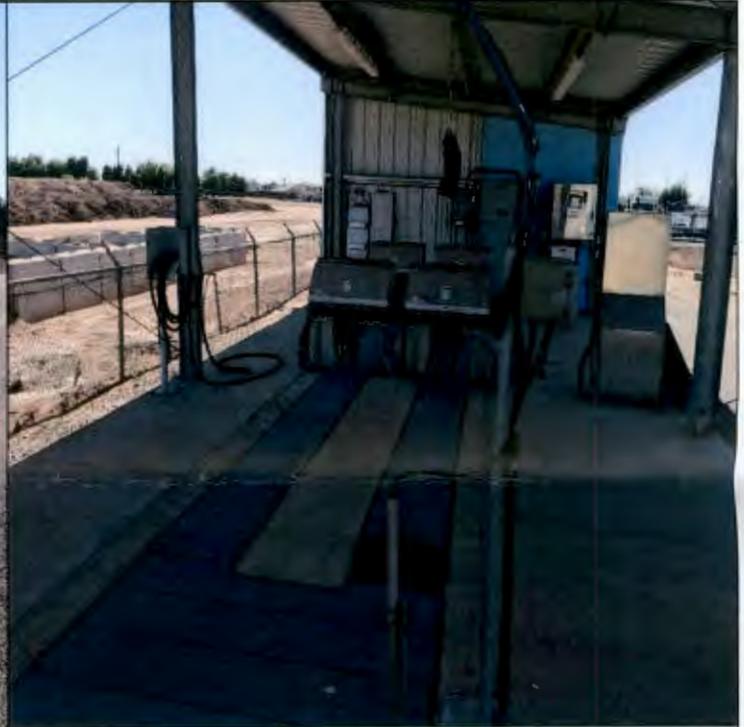
Photo 6.- UV disinfection system
