# HEBER PUBLIC UTILITY DISTRICT

## REPORT TO BOARD OF DIRECTORS

**SUBJECT:** Presentation on condition and possible update to HPUD Wastewater Treatment Plant

### HEBER PUBLIC UTILITY DISTRICT WASTEWATER TREATMENT PLANT

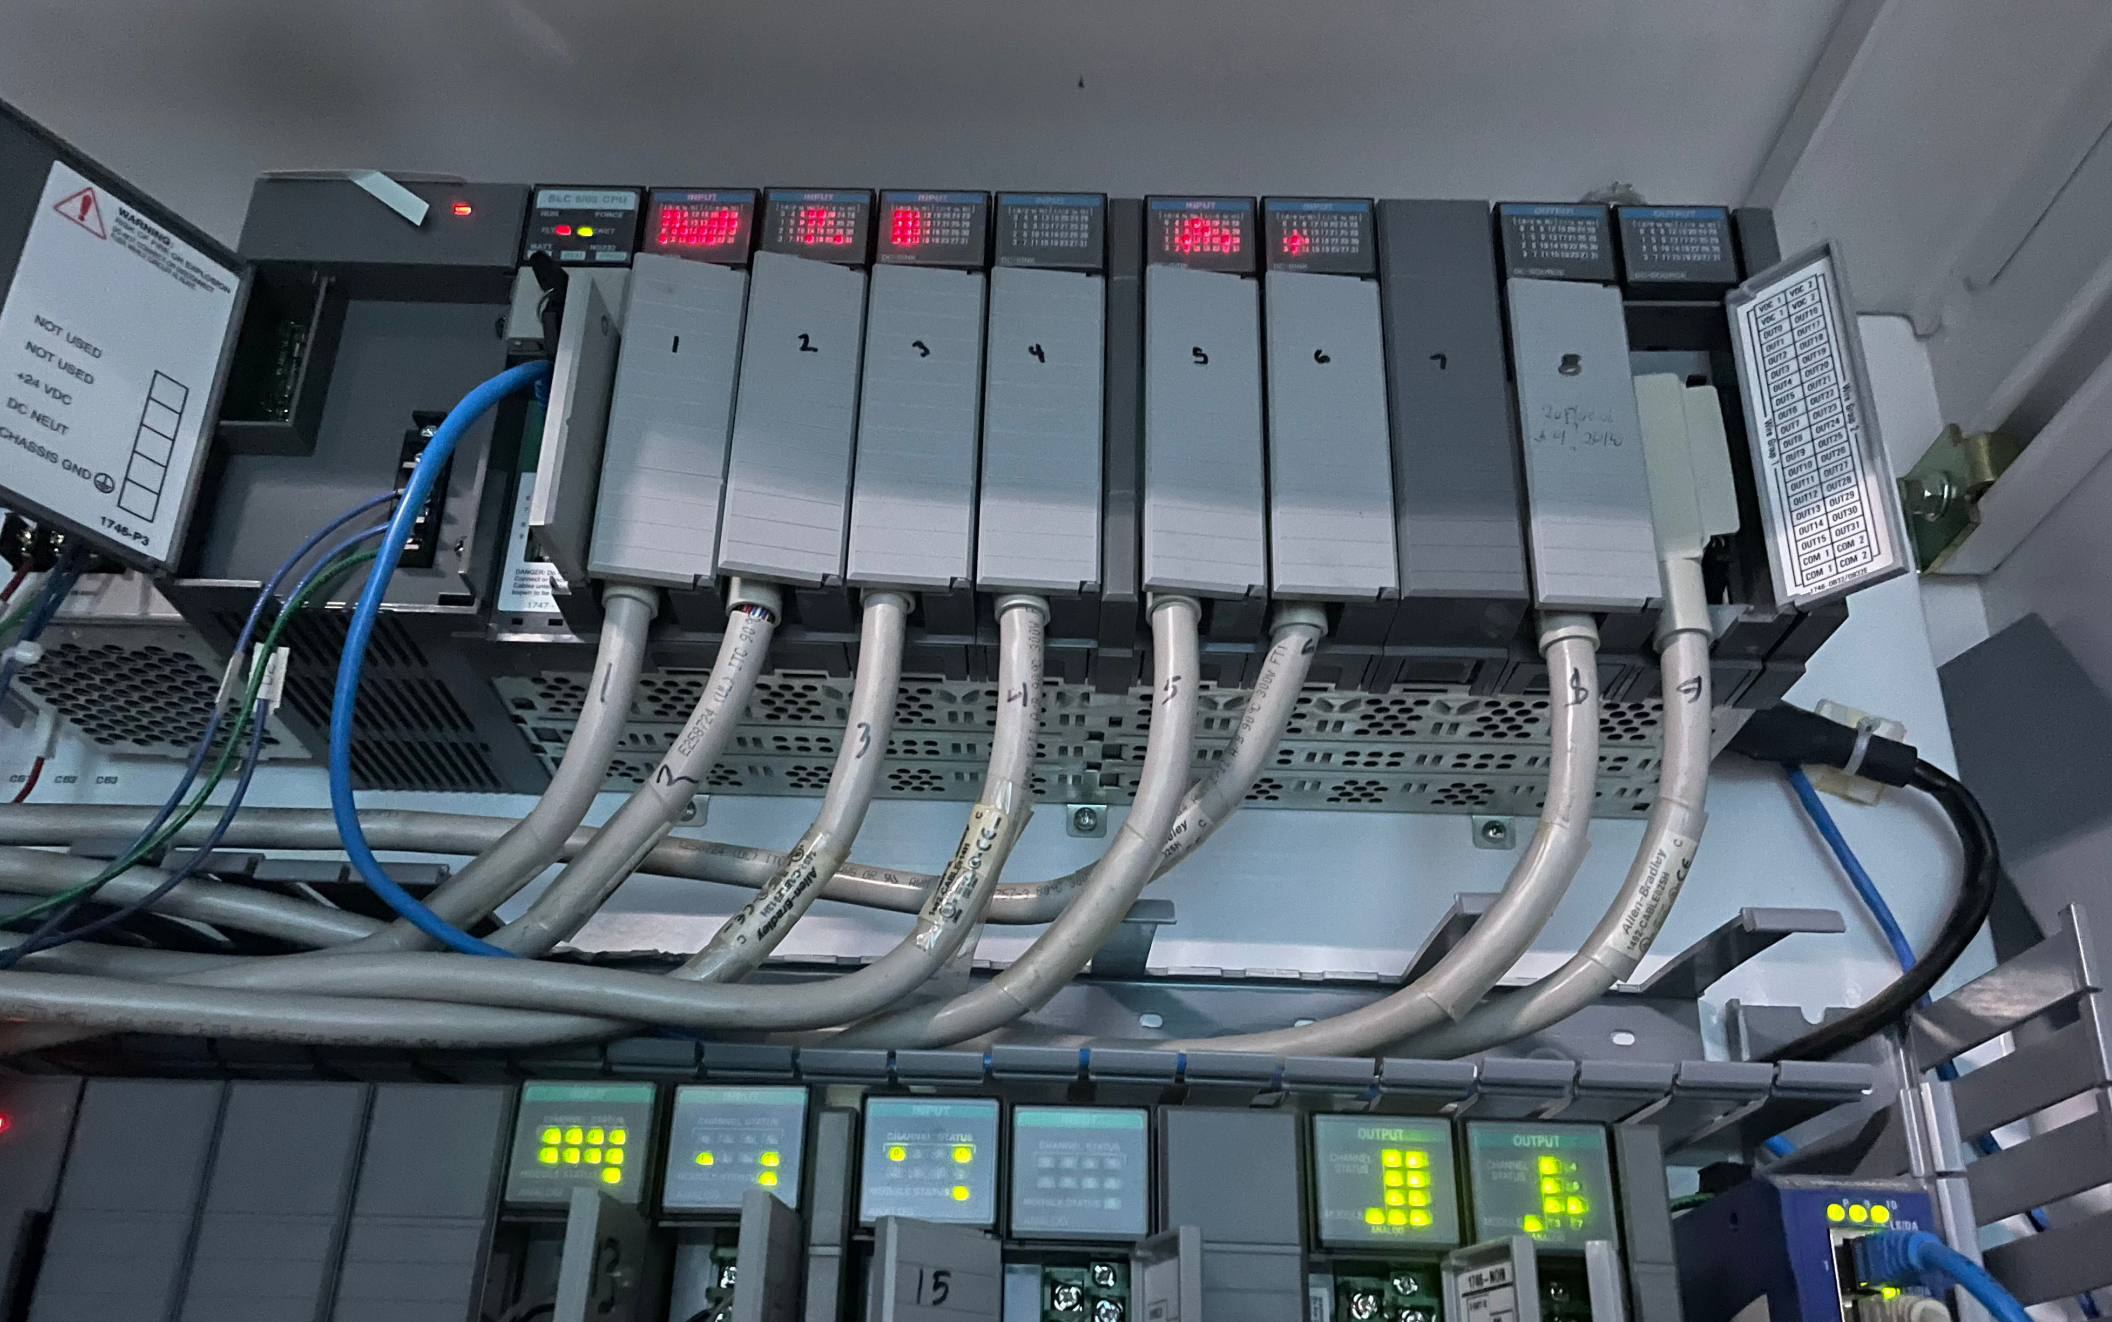
Headworks PLC (Programmable Logic Control) is the brains of the automated system that controls the equipment. This also sends out alarms in cases of emergencies or breakdowns.

This recommended repair needs to include relocation of the entire electrical system (emergency generator transfer switch, SCADA system, and PLC) about 100 feet to the Southeast. This relocation would prevent corrosion caused by exposure to hydrogen sulfide gas.

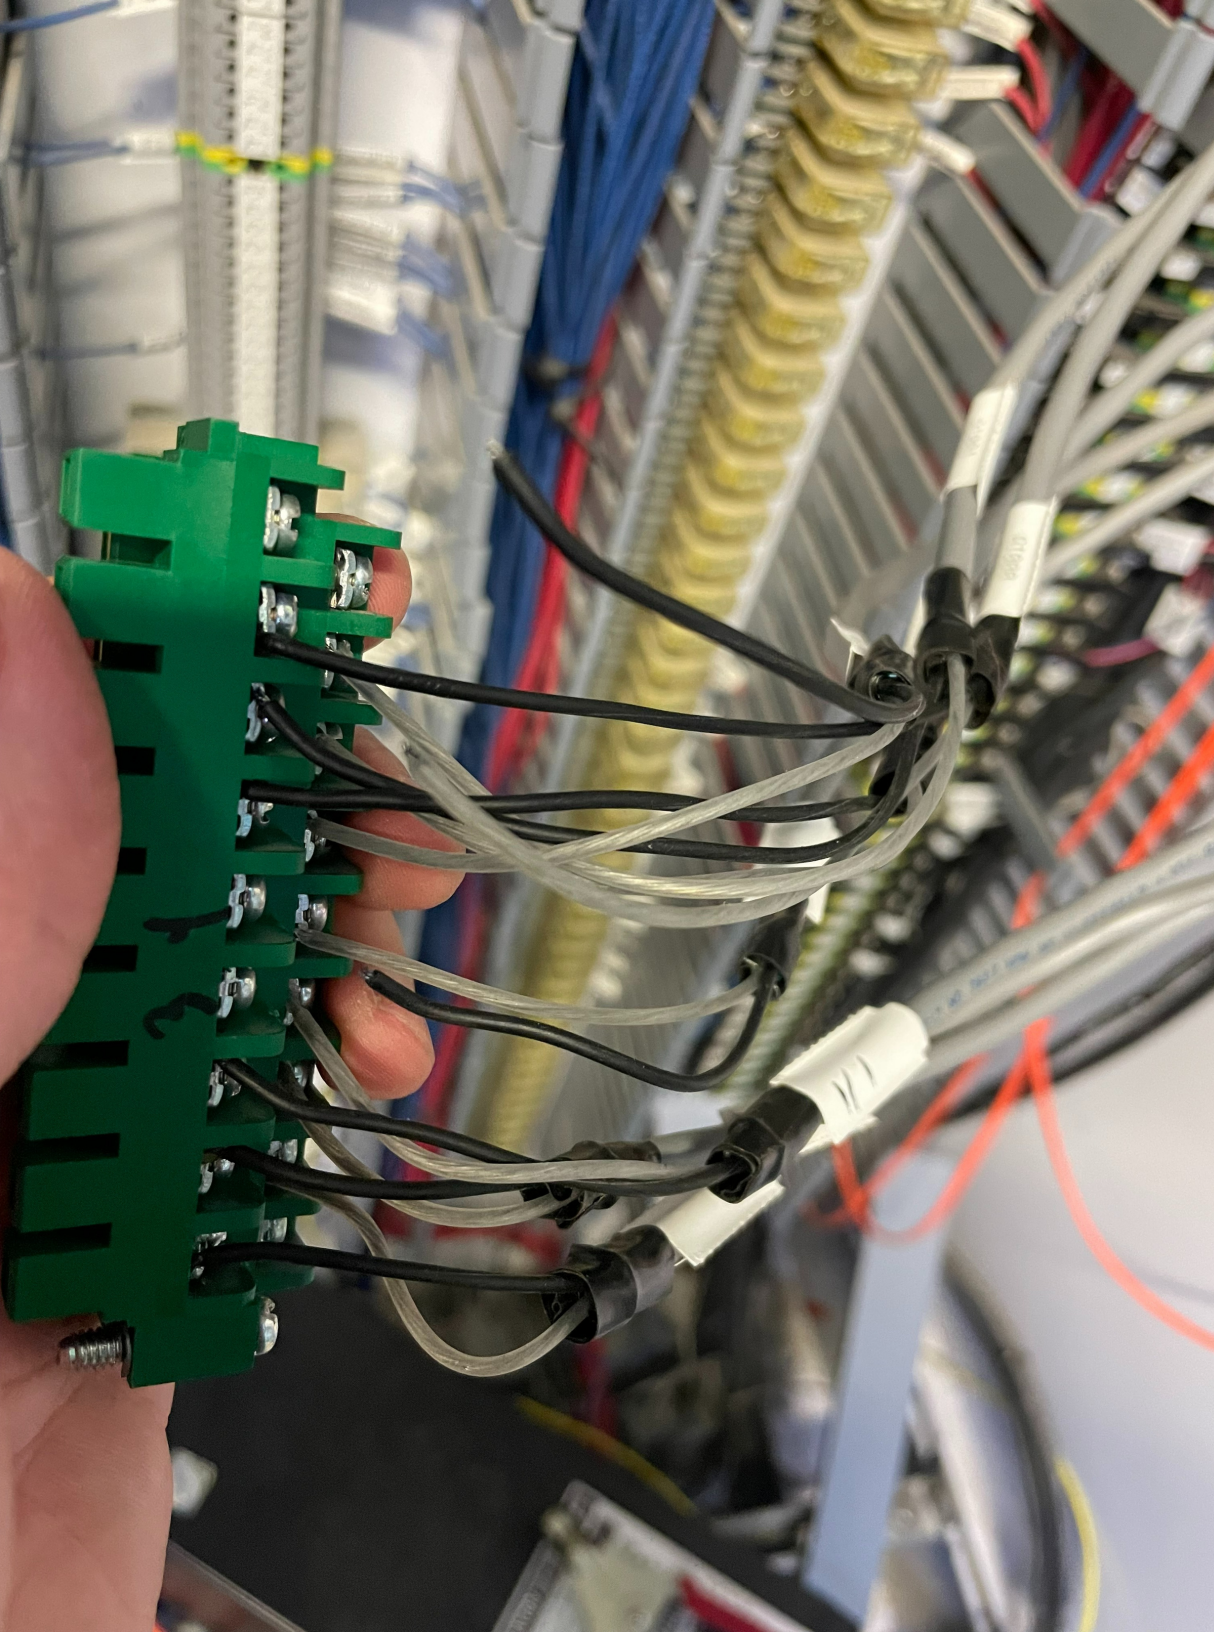
This is one component of a PLC, each wire must be connected at all times to be able to function. Due to the H<sub>2</sub>S gases these components fail frequently due to corrosion. Each PLC costs about \$4,000.

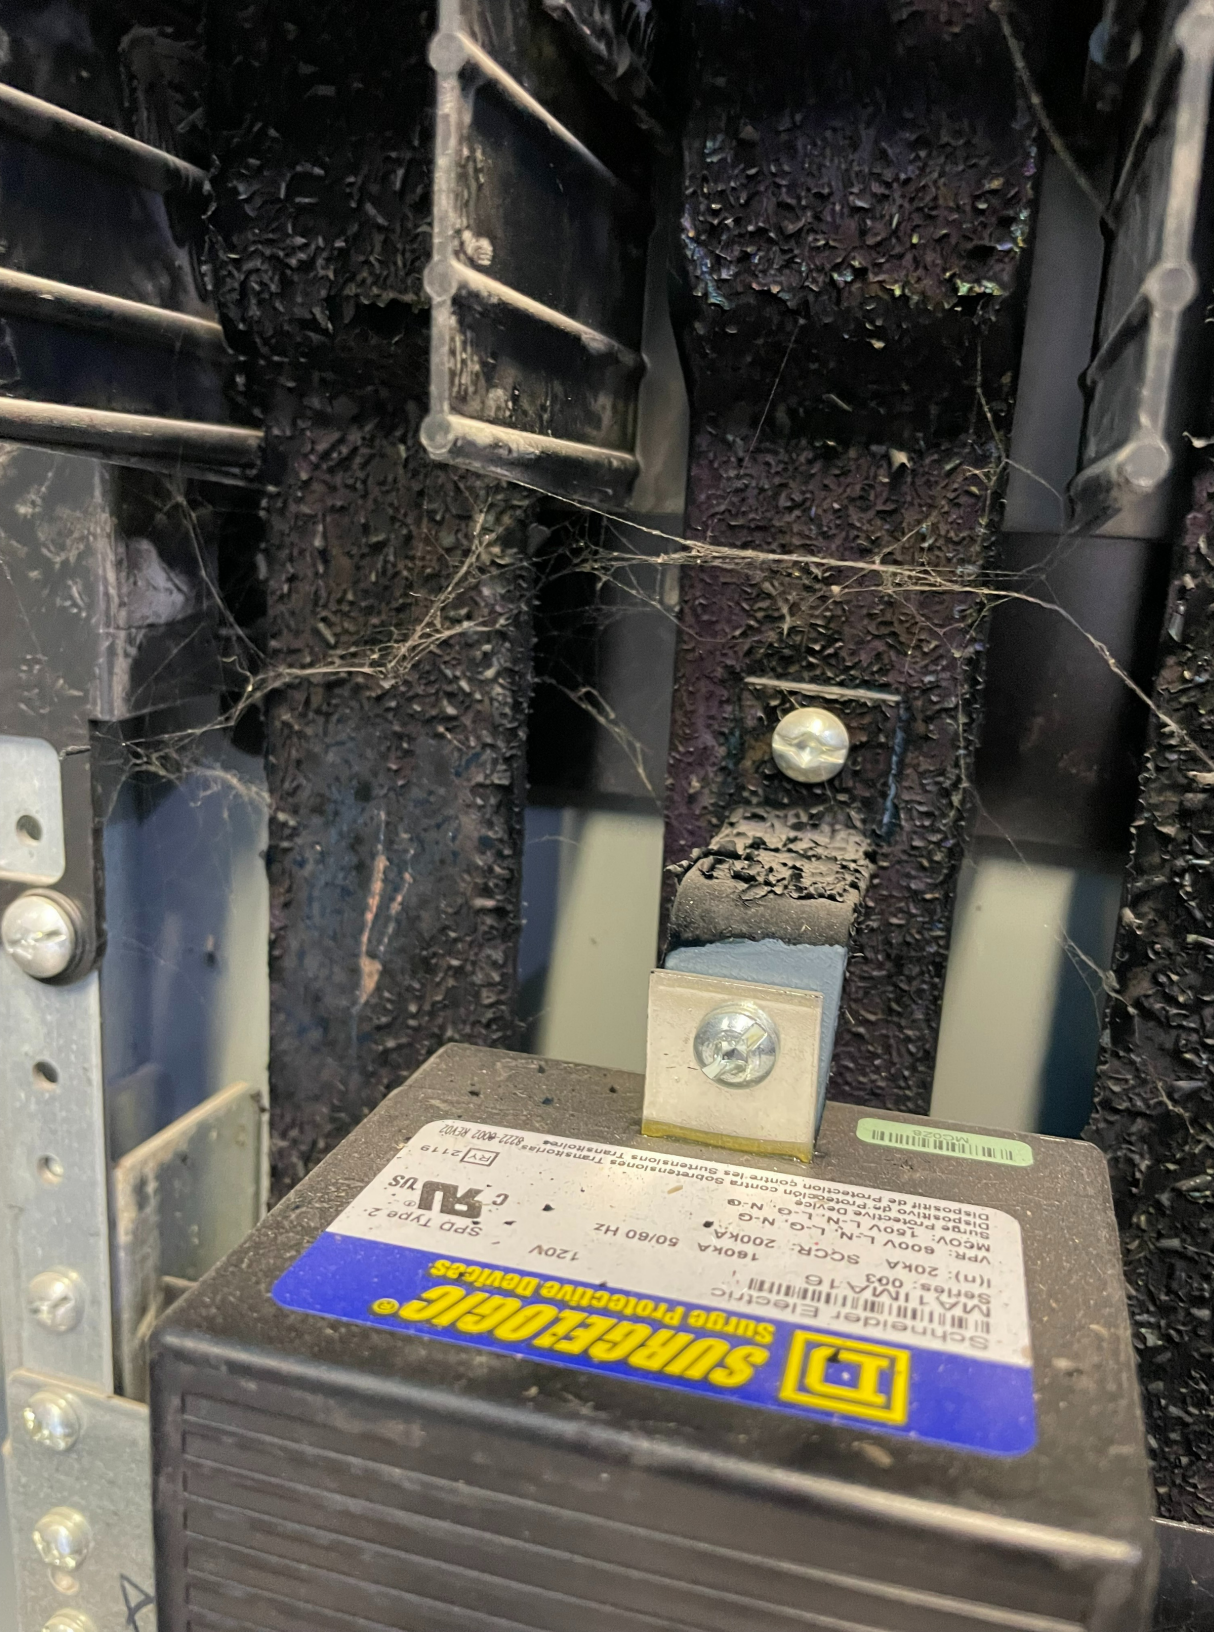
This shows H<sub>2</sub>S corrosion. This is the headworks circuit breaker, where there is black, and flakey spots that is H<sub>2</sub>S corrosion. The original color should be a silver metallic color.

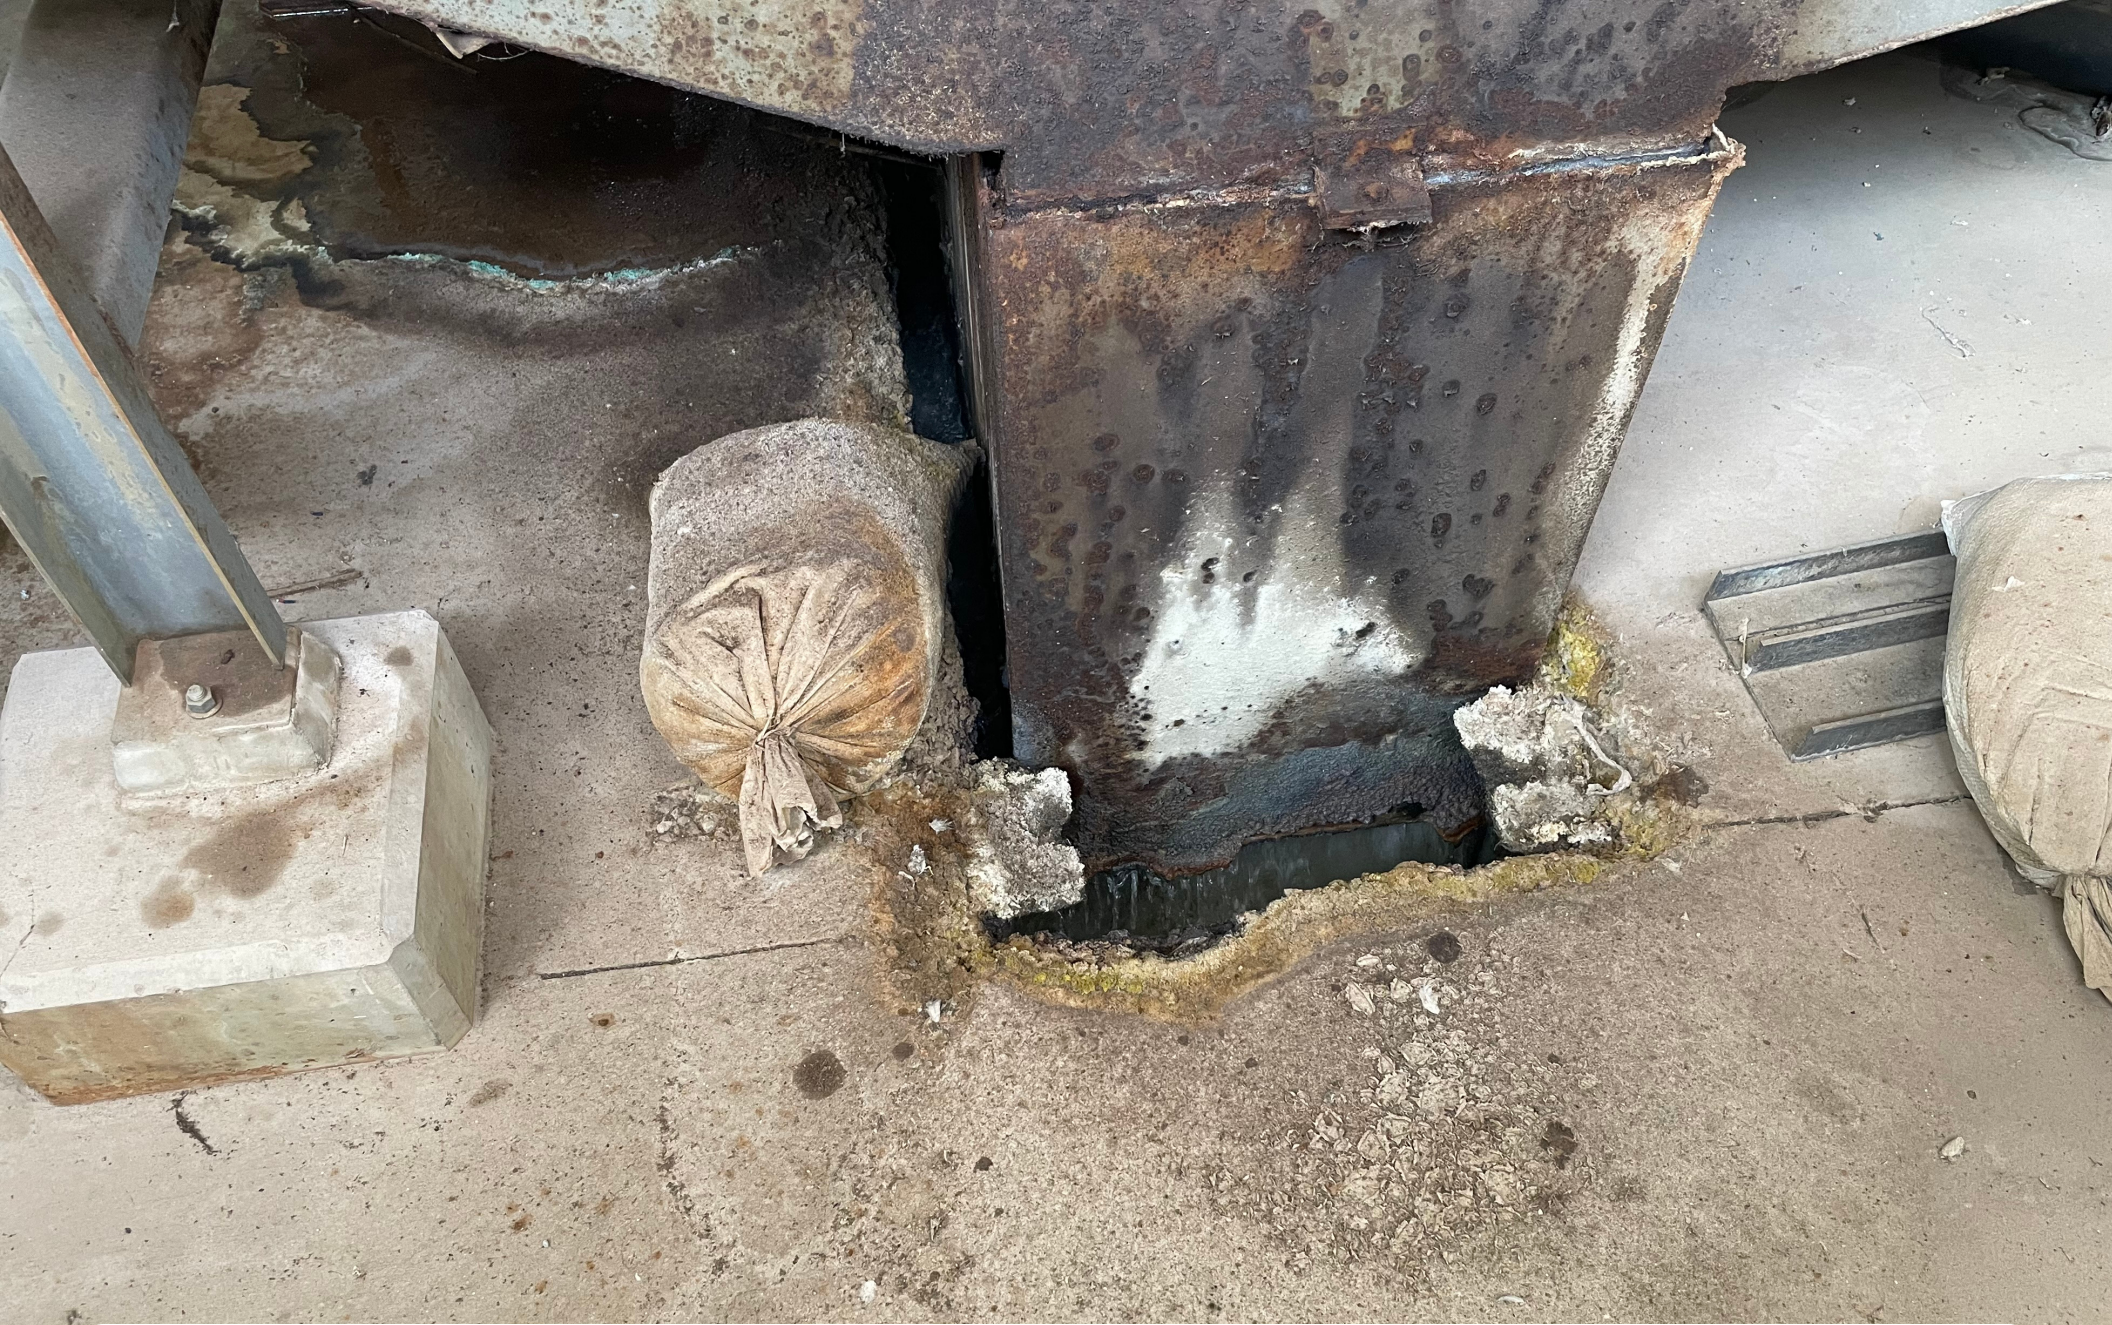
This is another example of H<sub>2</sub>S corrosion. This is a raw sewage drum screen foundation. This foundation is being corroded by constant H<sub>2</sub>S gasses.

As previously mentioned, the Headworks facilities emit sewer gases (hydrogen sulfide) that are corrosive to steel and concrete material which are in all and most of the headworks' facilities. The gases have created short lives for the various equipment and components. The constant repair and replacement, such as the concrete walls of the Grit Chamber or steel screens for the Drum Screens, continues to increase operating costs. Capital costs in the replacement of various equipment would benefit the operation and maintenance schedule of the wastewater treatment plant. The installation of Odor Control equipment would also extend the life of any existing equipment and new equipment within the Headworks Building. The existing Influent Channel of the Headworks Facility, located within the Headworks Building, is constructed of concrete with epoxy coating lining. The corrosion by sewer gases has corroded through portions of the epoxy lining and is spalling the existing concrete channel. To save the overall structural integrity of the channel, the concrete, and the epoxy-lined channel needs major repair.

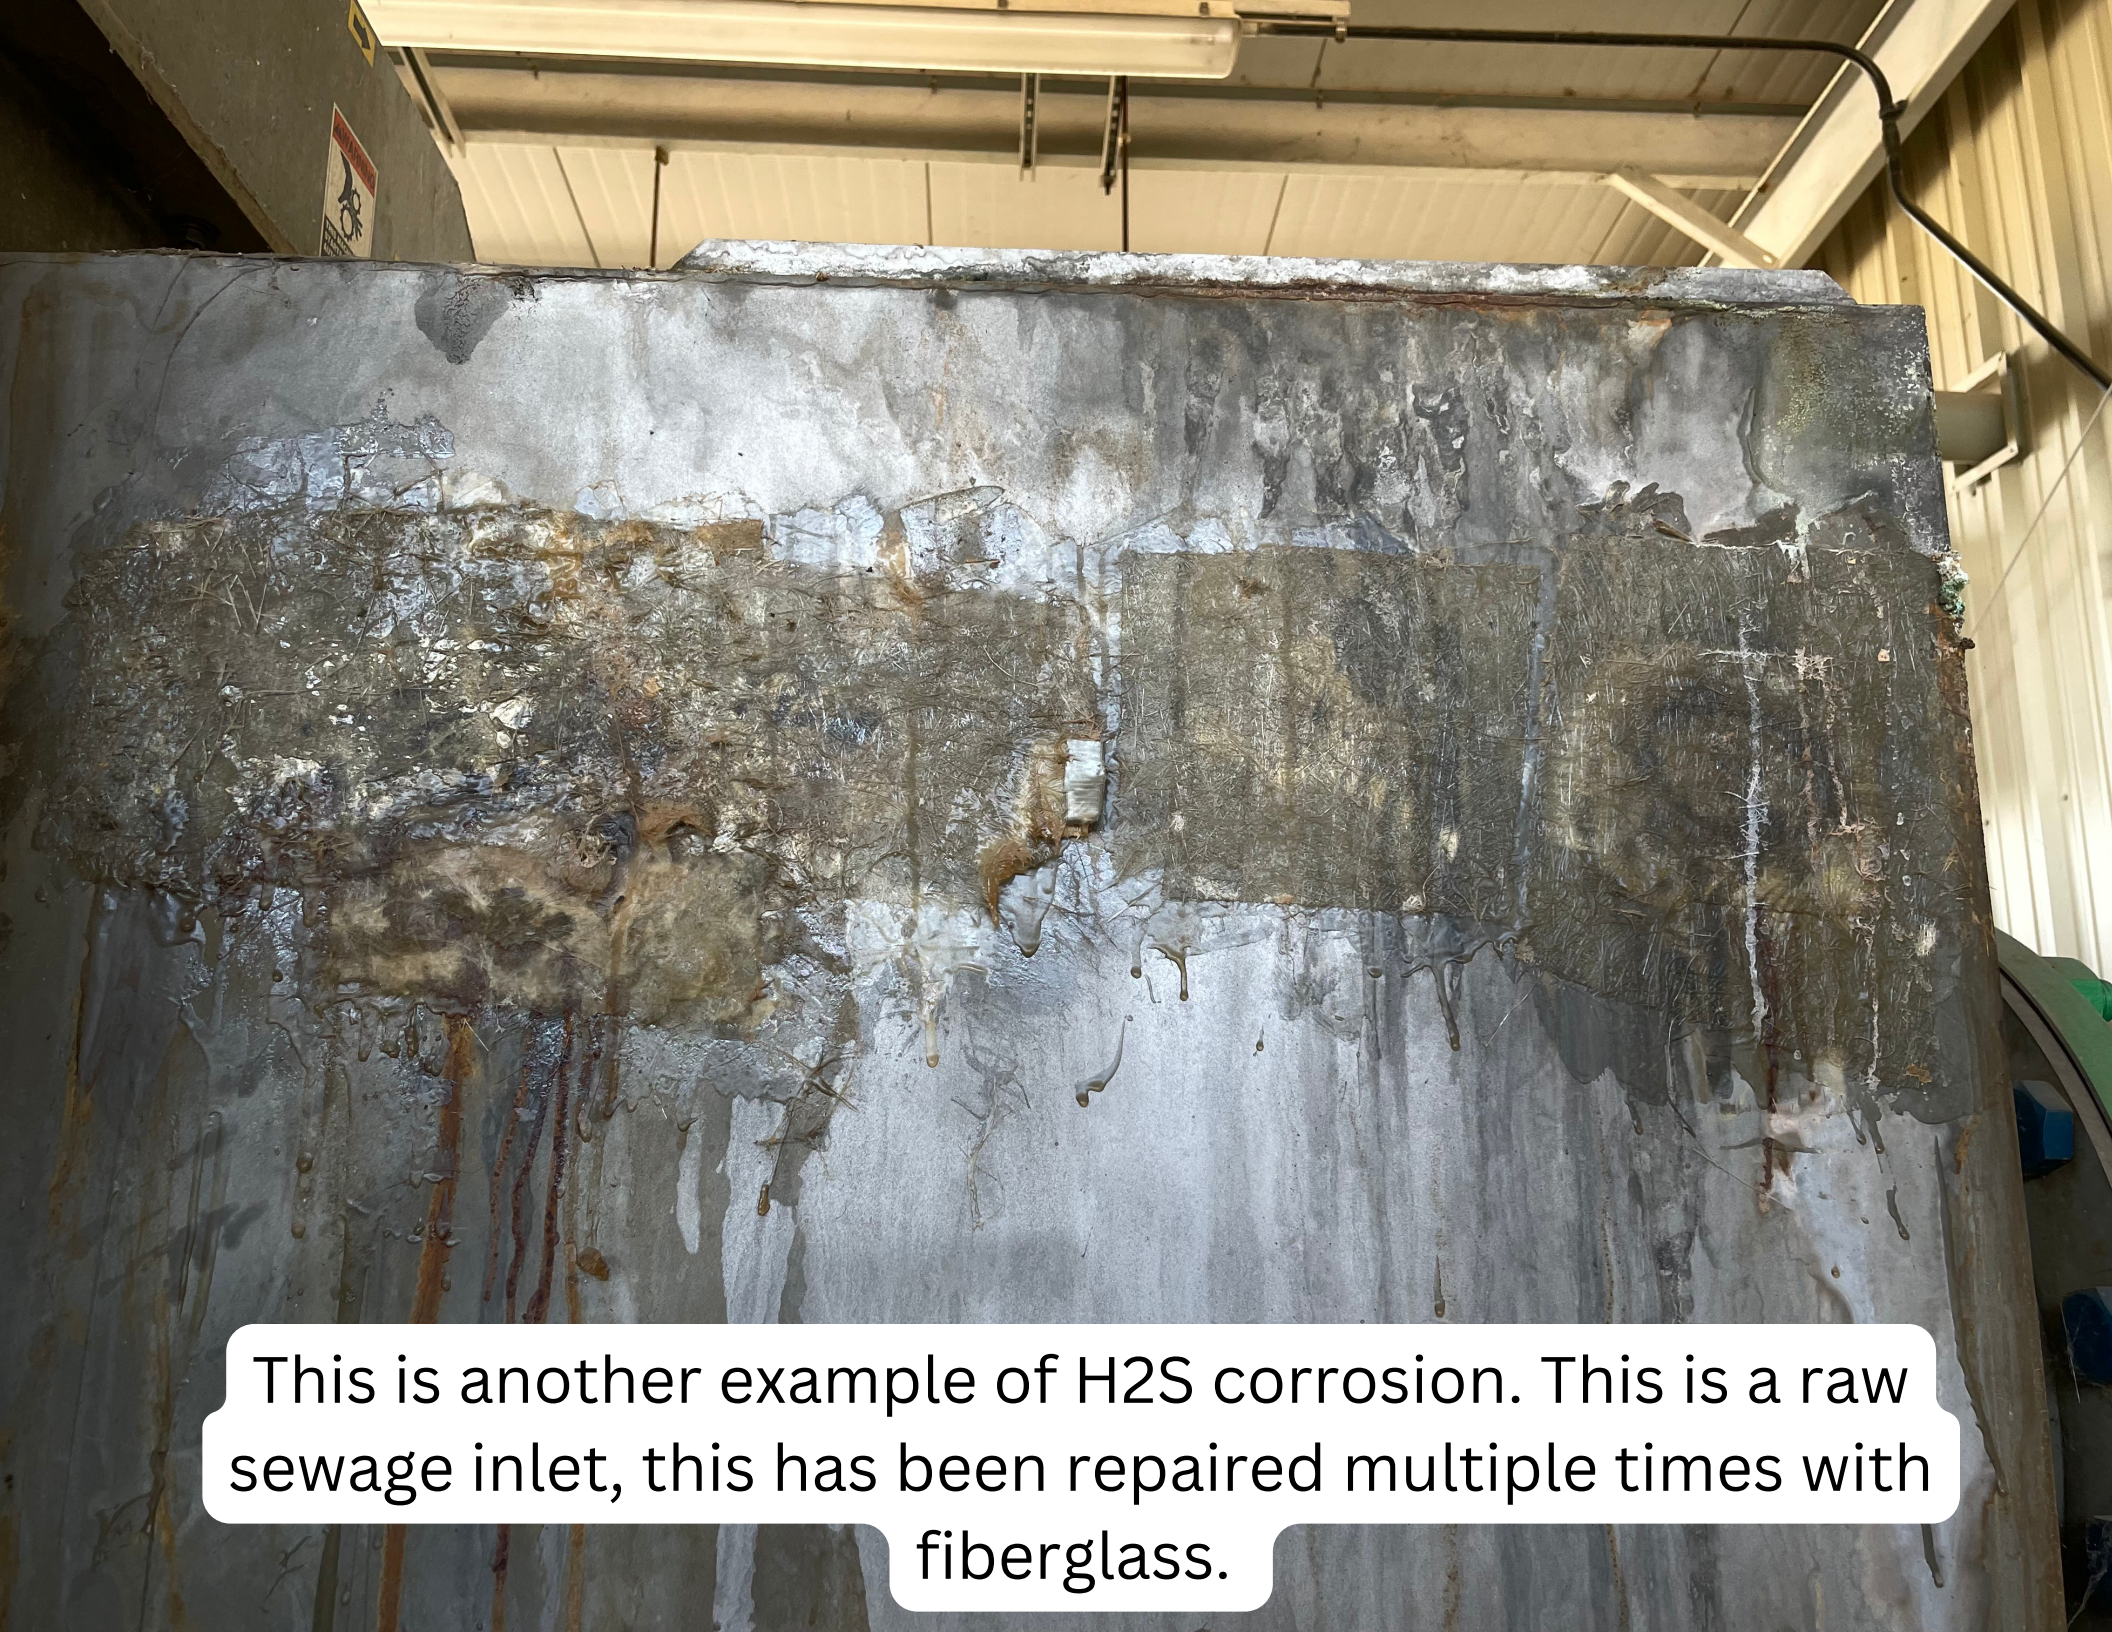
This is another example of H<sub>2</sub>S corrosion. This is a raw sewage inlet, this has been repaired multiple times with fiberglass.

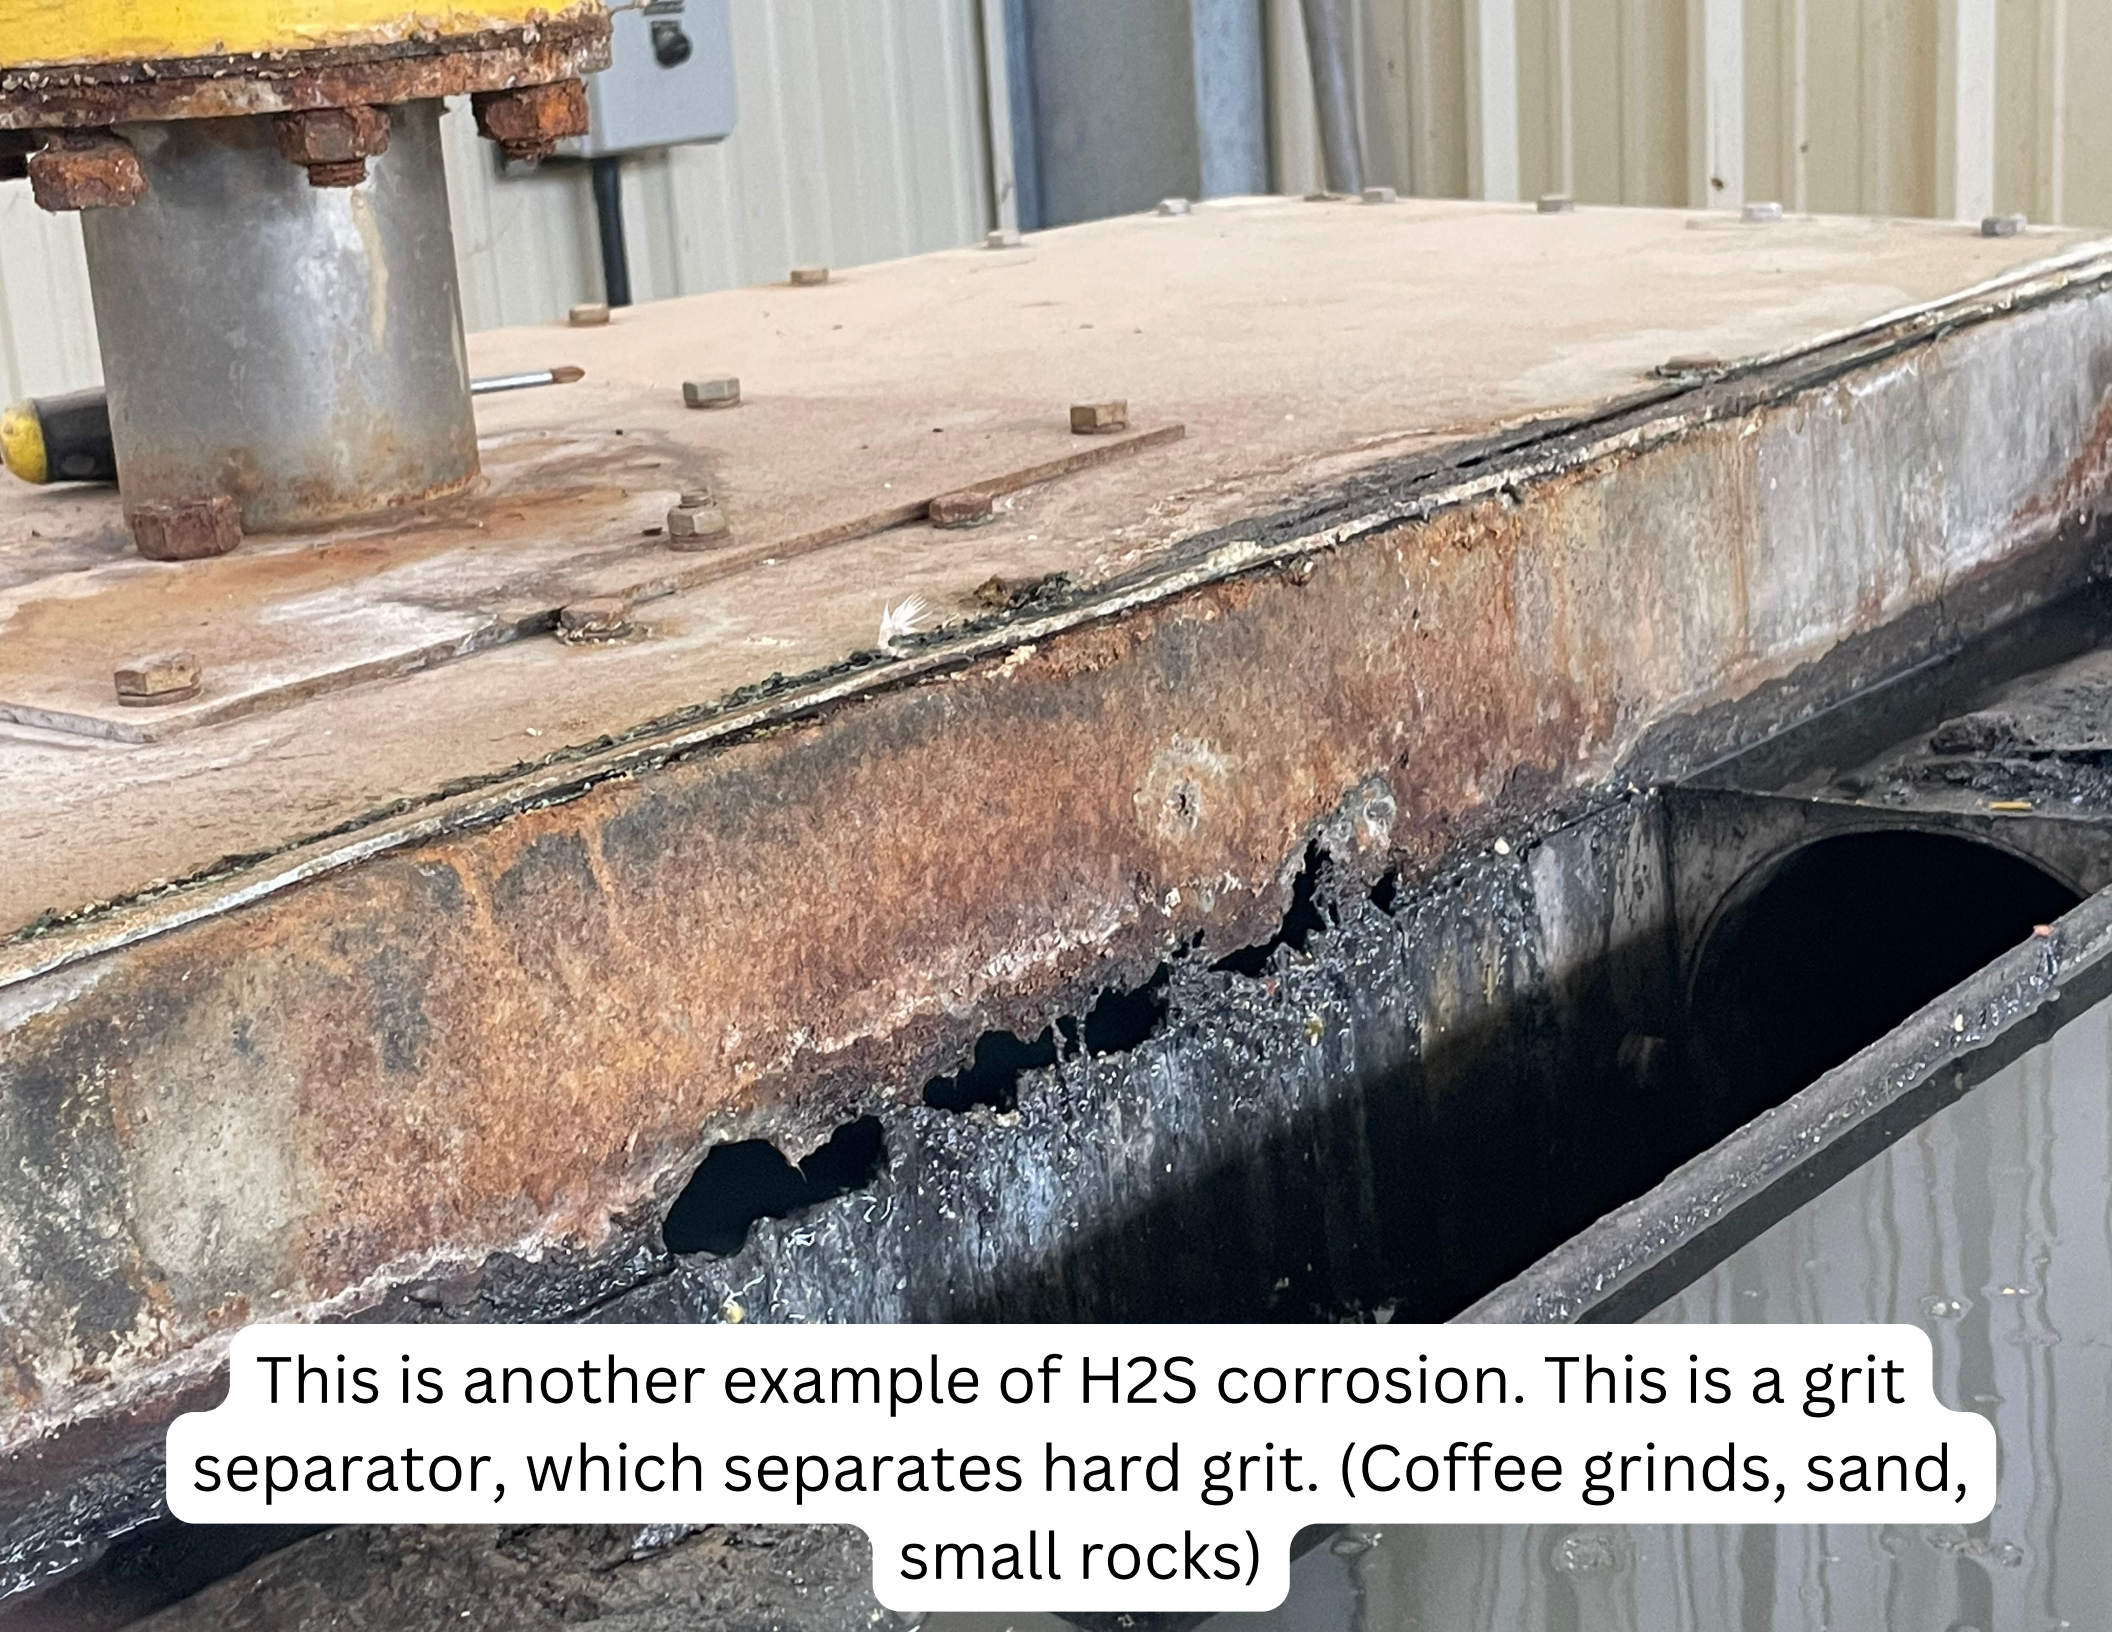
This is another example of H<sub>2</sub>S corrosion. This is a grit separator, which separates hard grit. (Coffee grinds, sand, small rocks)

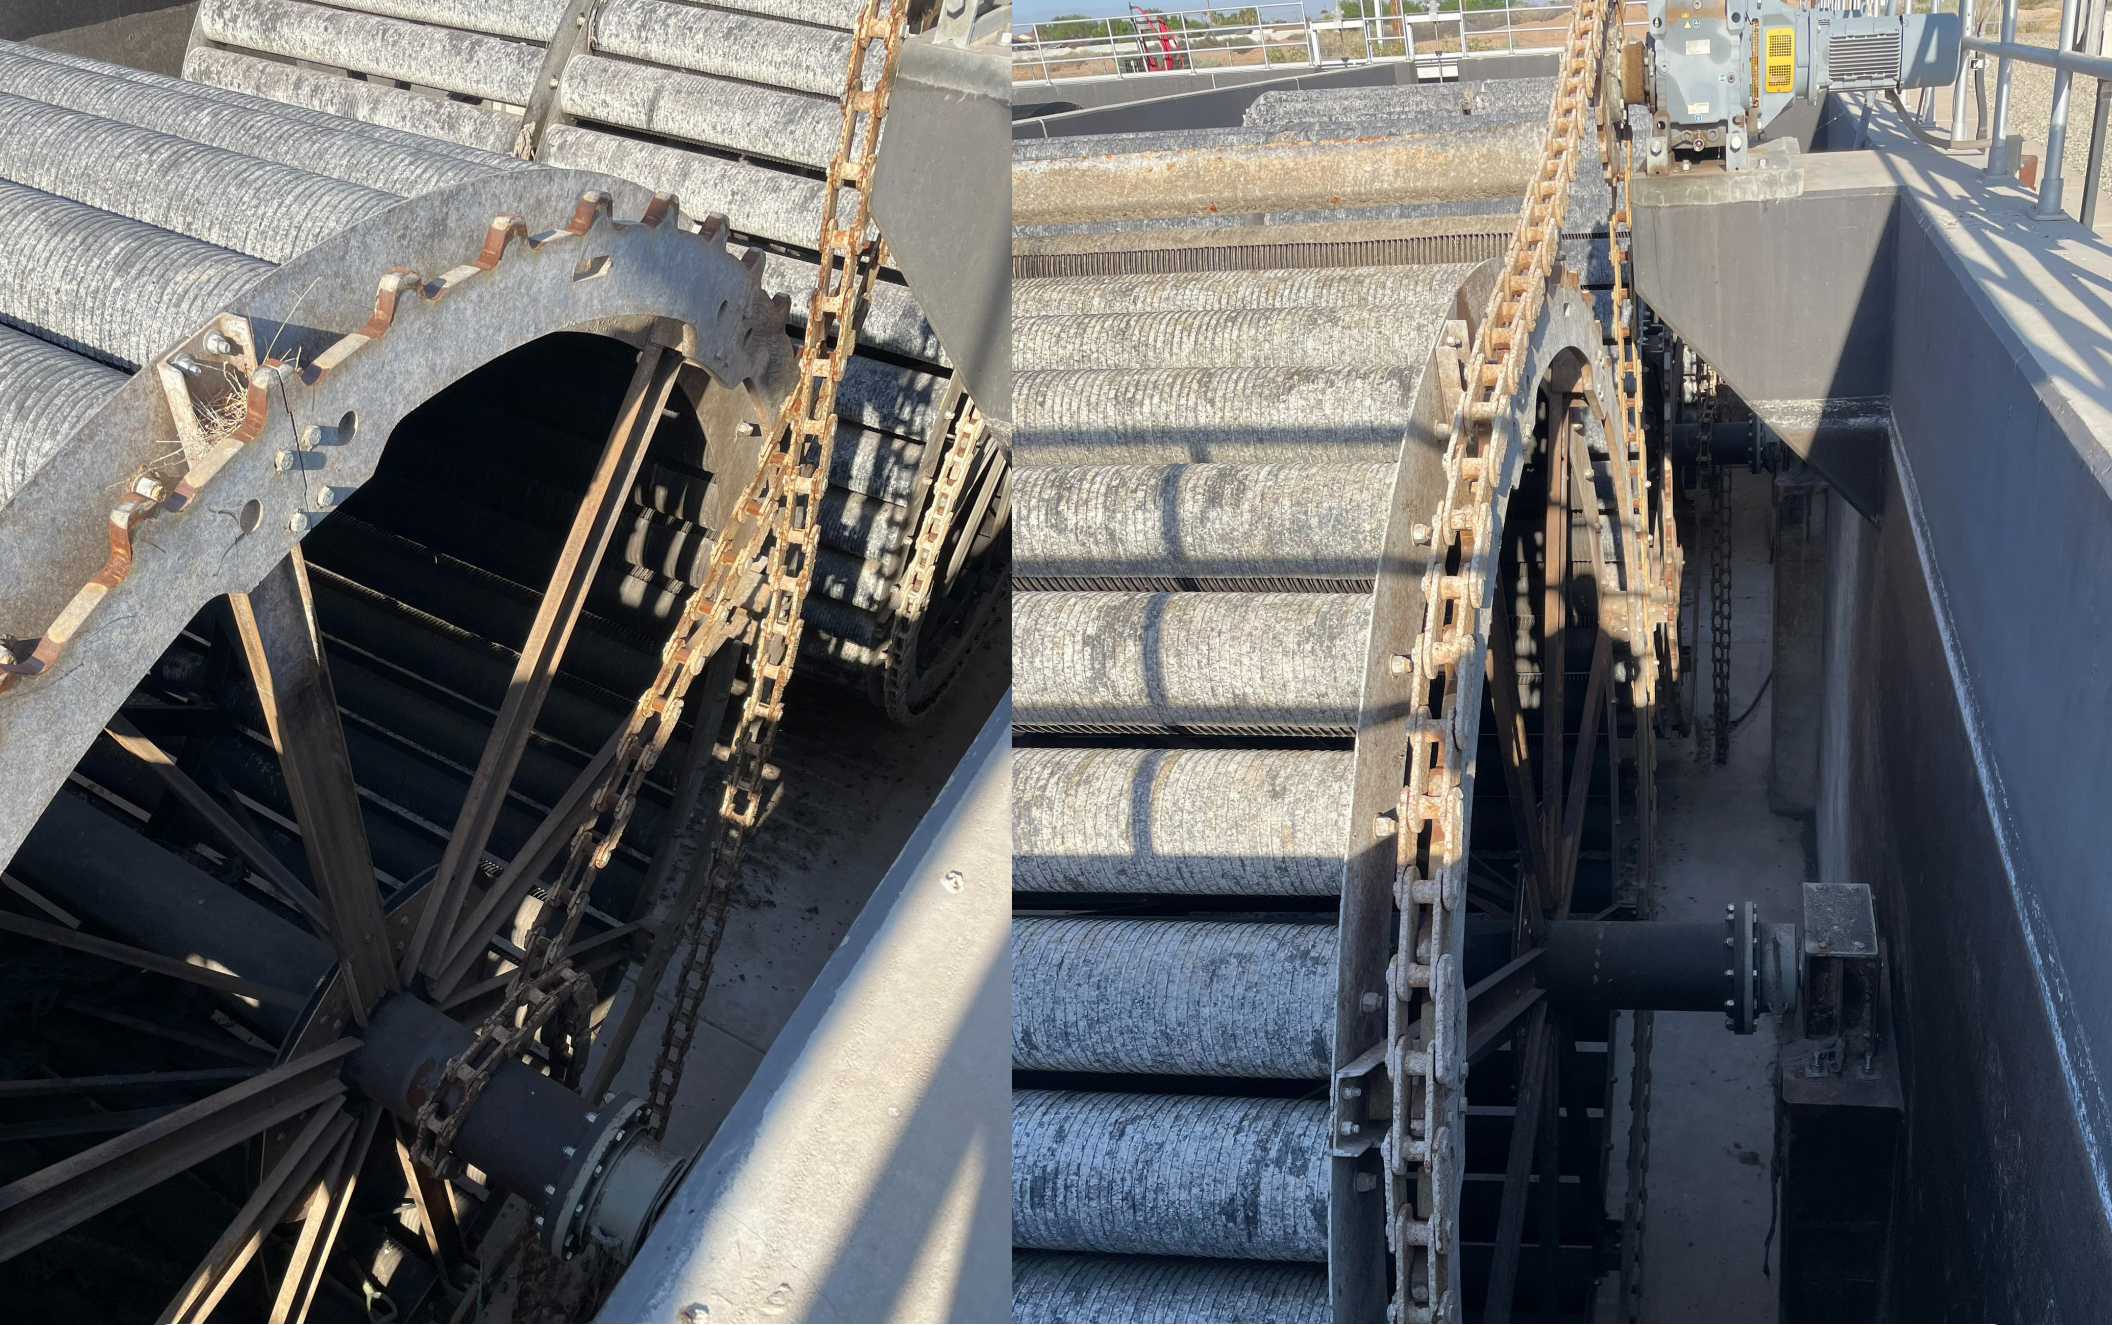
This is the Aerotor, this introduces oxygen into the aeration system that allows the treatment to progress. These chains are 6-8 years old.

There are two existing STM-Aerotor Treatment Units that provide biological treatment of wastewater. The Aerotor Treatment Units are mechanical moving and paddle-mixing systems that were installed in 2014. The Aerotor Treatment Units have been experiencing various issues with the most occurring issue being the breaking of structural beams and chains. However, the concrete structure that houses Aerotor Treatment Units is in good condition. This constant maintenance and repairs of the various components have now deemed the need to conduct a major retrofit of the overall Aerotor Treatment Units. The retrofit of the units would enable the overall life and operational use of the Aerotor Treatment Units.
