HEBER PUBLIC UTILITY DISTRICT REPORT TO BOARD OF DIRECTORS

SUBJECT: Update on the Shade Structure at the Water Treatment Plant Capital Improvement Project and Condition of Shop Building

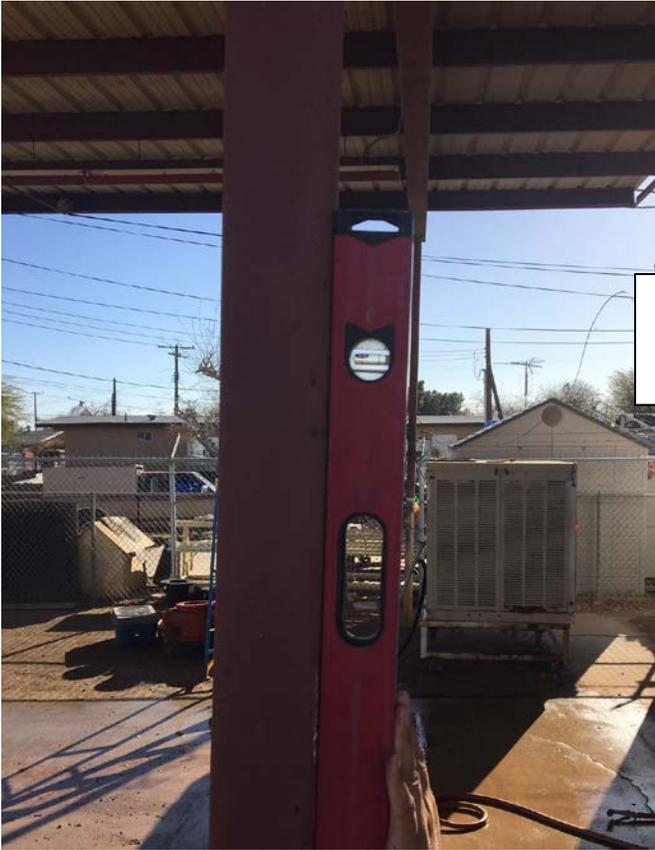
As you can see in the pictures below, the shade doesn't have cross beams and is leaning. The foundation and corner poles are weak and the above ground bolts are corroding and some are loose.

As you know the replacement of the shade structure at the WTP shop has a \$200,000 budget included in the CIP project list for FY 18-19. Staff has met with a licensed contractor to determine what can be done with the existing shade and to inspect the shop building. The shade cannot be repaired or relocated, but the metal can be salvaged and recycled.

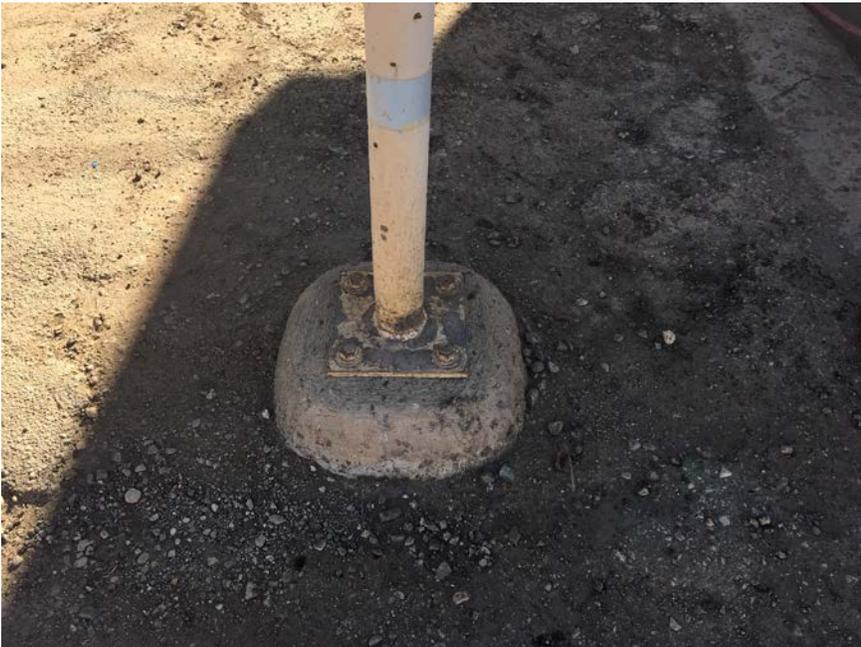
Notice the bubble in the level to the left. This is one of the four poles holding up the shade.

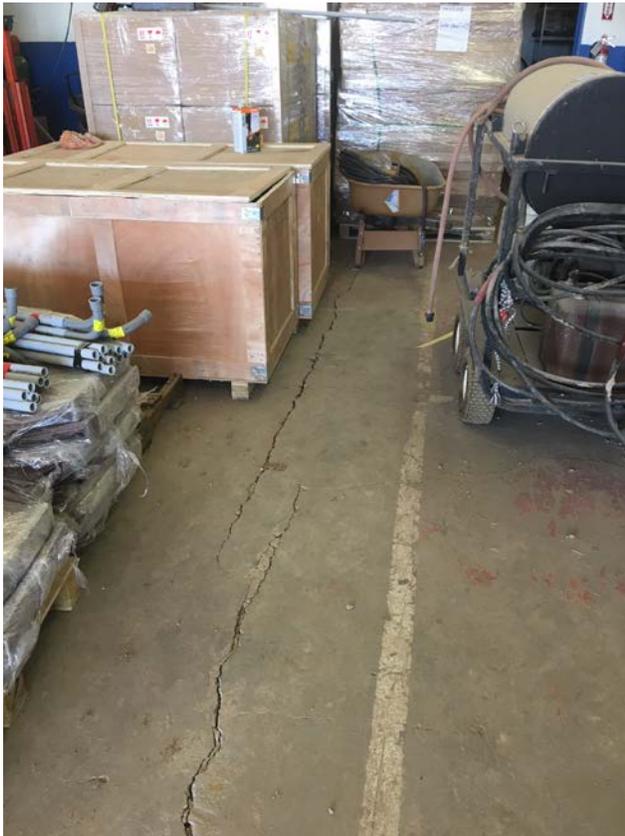
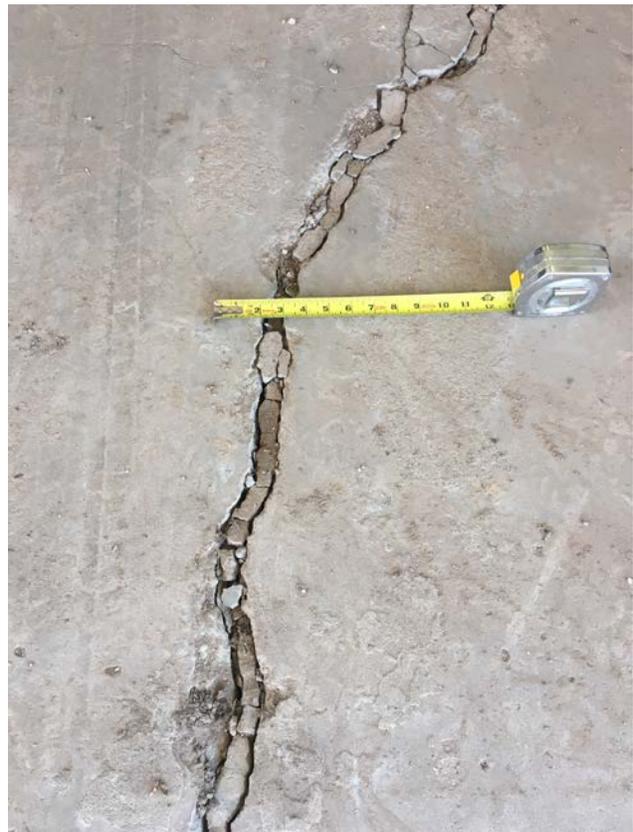
Additionally, the contractor noted large cracks in the current shop building cement foundation. He noticed that it had been repaired once, but has cracked open. He advised that the cement will continue to erode and the foundation cracks will expand. The crack is about 1 inch wide and runs down the entire length of the building. The current building's electrical service and wiring would need to be replaced as well. Francisco and his crew repaired the roof about 15 years ago.

The current shop building is fine for now, but will eventually need a large investment to replace the foundation. If left as is, it could be used for just storage (non-human use). The photos below show the crack down the middle of the shop building.
